The **Cannot initialize reader connection error** which you got while trying to load the CV act sc interface utility of the Cryptovision smart card software is a Microsoft Windows issue. See the result of investigations carried out and a suggestion for fixing it below

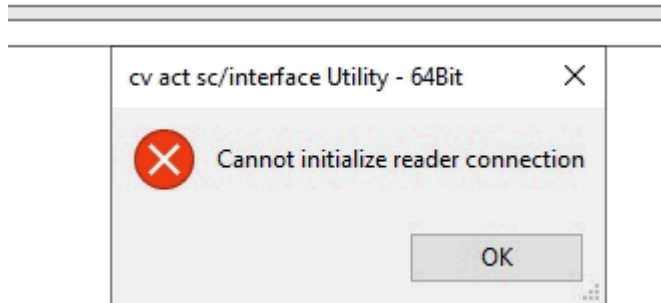
Apparently there is some bigger issue with the Microsoft that causes some irregularity with the smart card service and handling of readers. Here is the feedback that I have from one of our senior developers:

“We discovered two problems after updating to windows version 1903 or higher using Windows Update. In all cases, the use of the smart card worked perfectly before the update.

1. The smart card service (SCardSvr) has been removed after the update. This happened in some cases we were not able to locate the smart card service (services.msc, “sc query scardsvr”).
2. The smart card service is running but an connection could not be established. A call to SCardEstablishContext always reports SCARD_E_NO_SERVICE.

In all cases, the device manager showed that the smart card readers are working and ready.

After some digging, we found a solution to restore the broken Smartcard Service **by running the Windows In-place Upgrade**.

https://answers.microsoft.com/en-us/windows/forum/windows_10-windows_install/how-to-perform-an-in-place-upgrade-with-windows-10/7f0b236e-3c6c-4913-9691-c4baa2a6190a
